June 24, 2020

2020 PAG Meeting

Northern Maine Transmission System

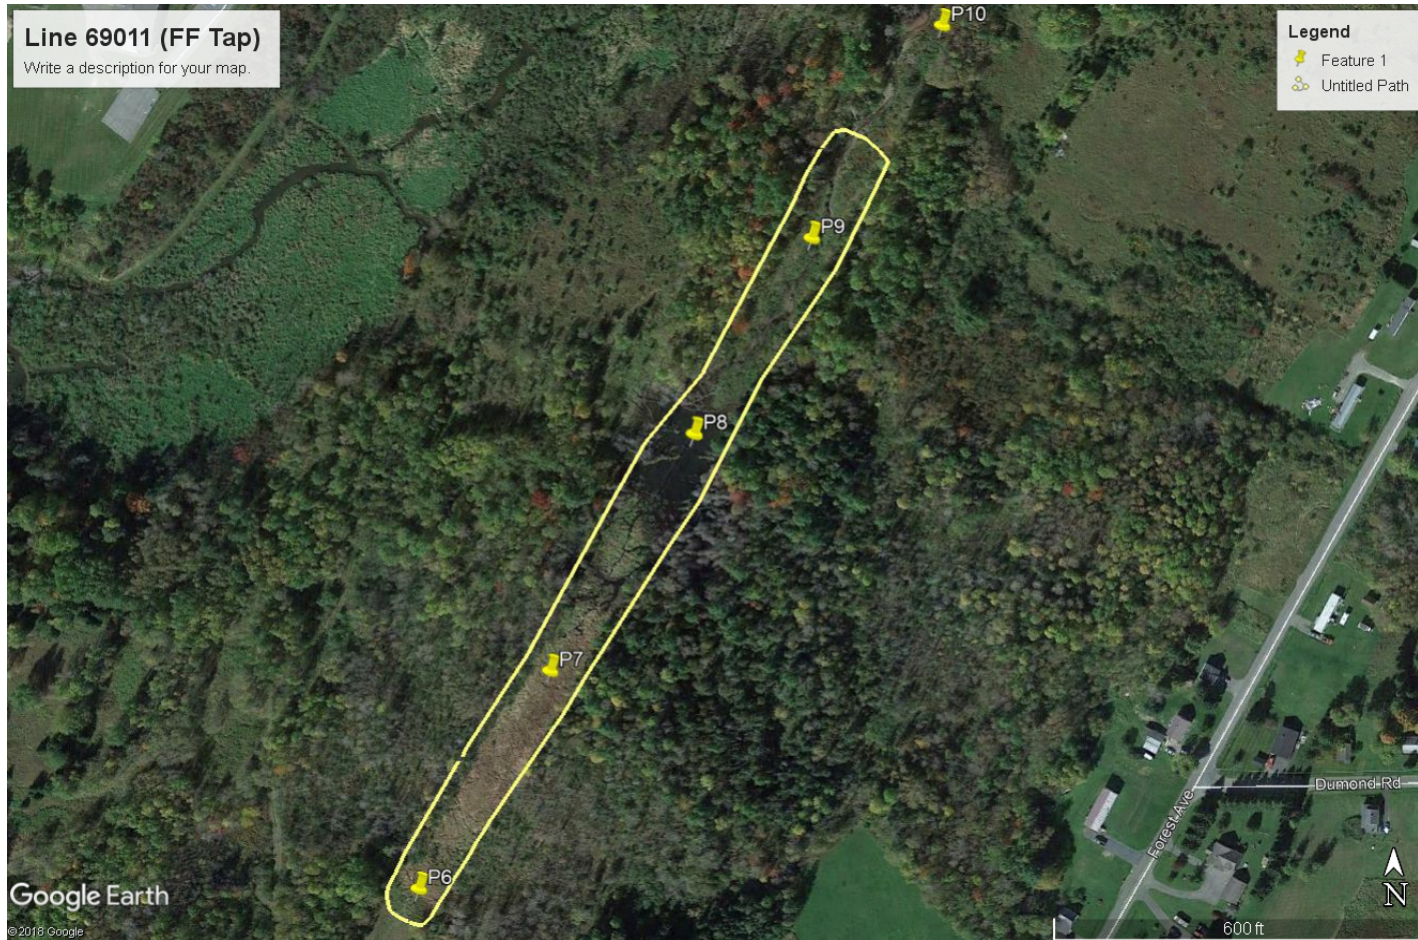
Line 6901 Fort Fairfield Tap

Wood poles #6 thru #9 in a beaver swamp, replaced with composite poles and bog anchors and guys

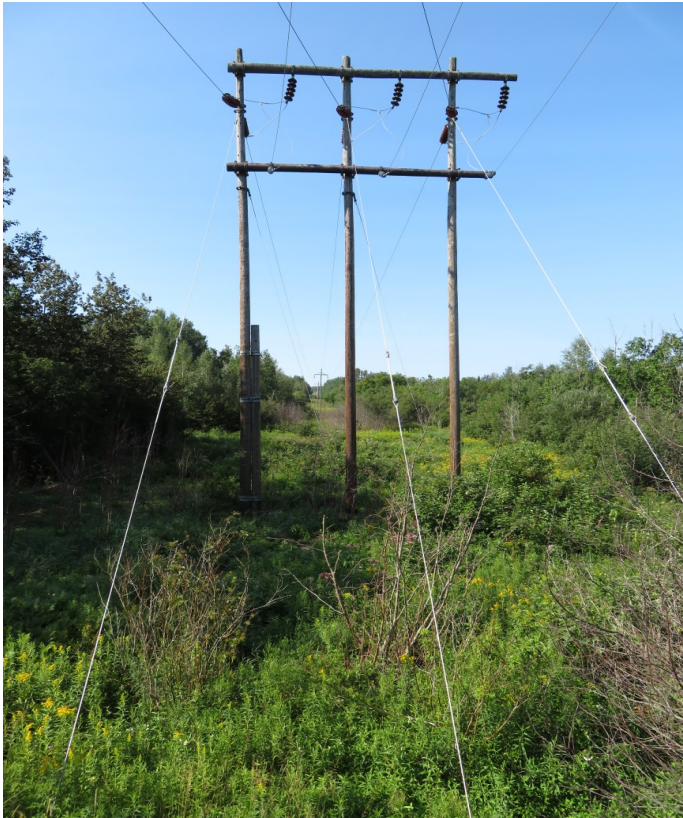
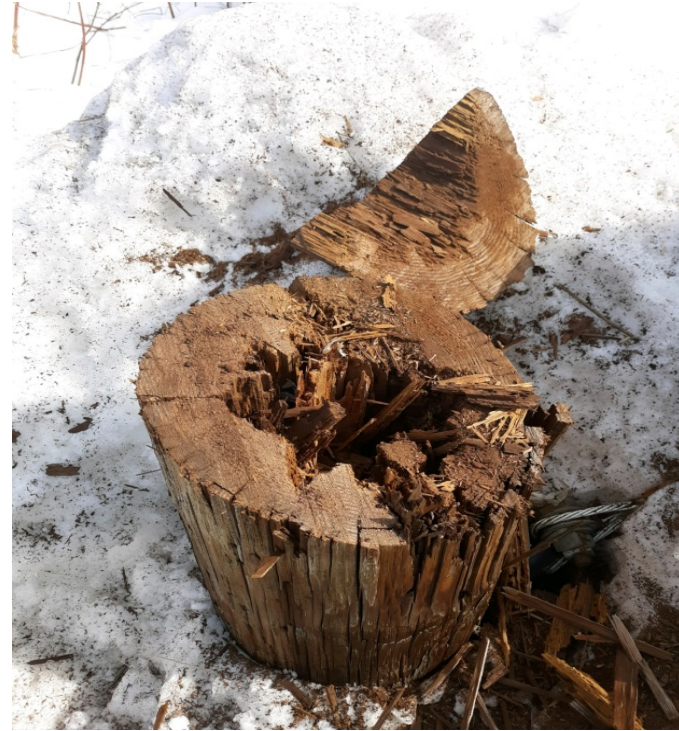
Line 6901 Fort Fairfield Tap continued...

Extremely poor condition three pole deadend structure, left pole previously stubbed to provide support for weakened pole, right pole rejected due to excessive internal decay.

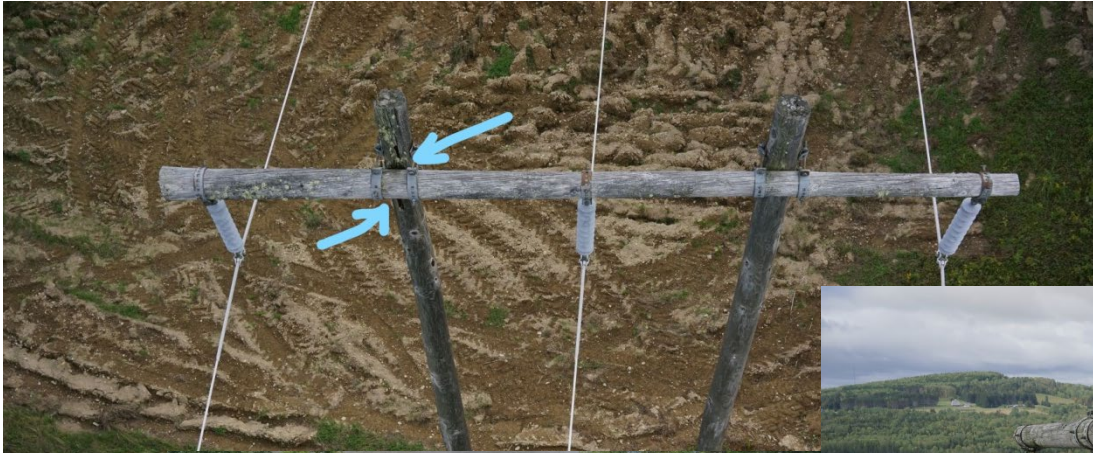
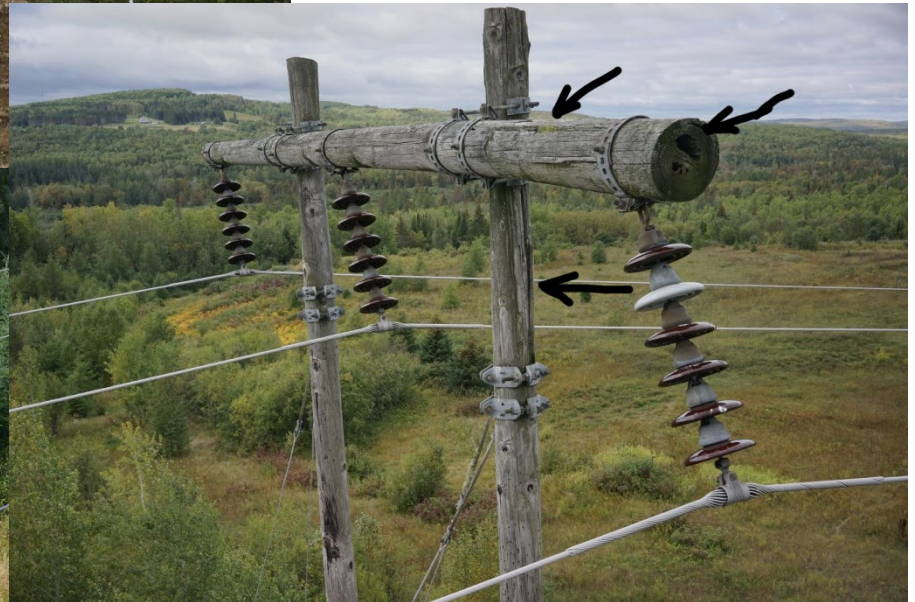
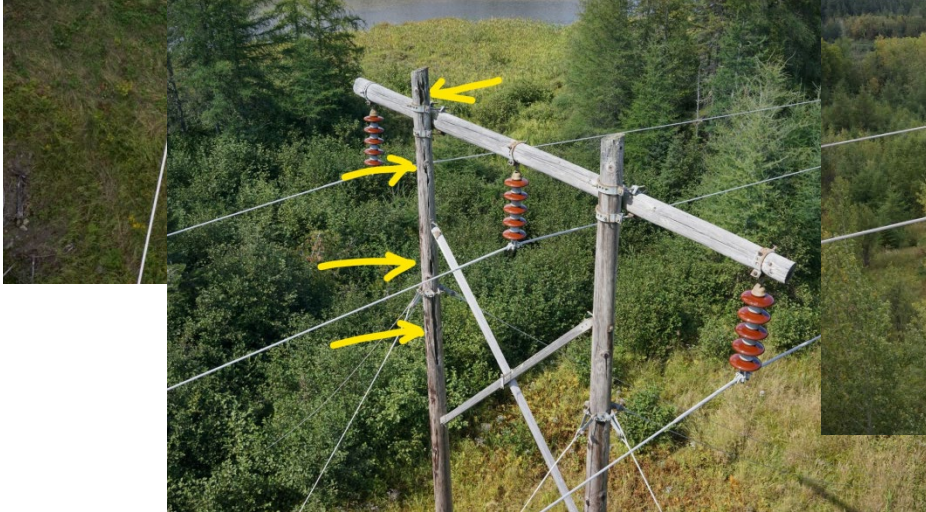
Line 6905

Excessive pole and crossarm rot detected by UAS (a.k.a. drone) inspection resulted in an emergency structure replacement project

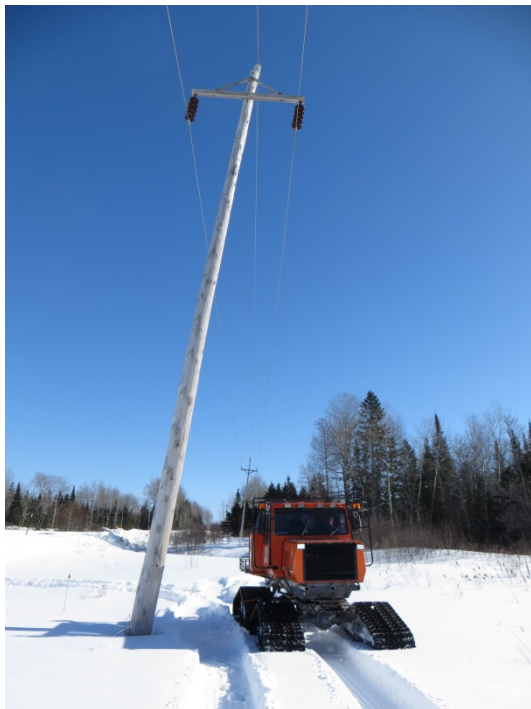
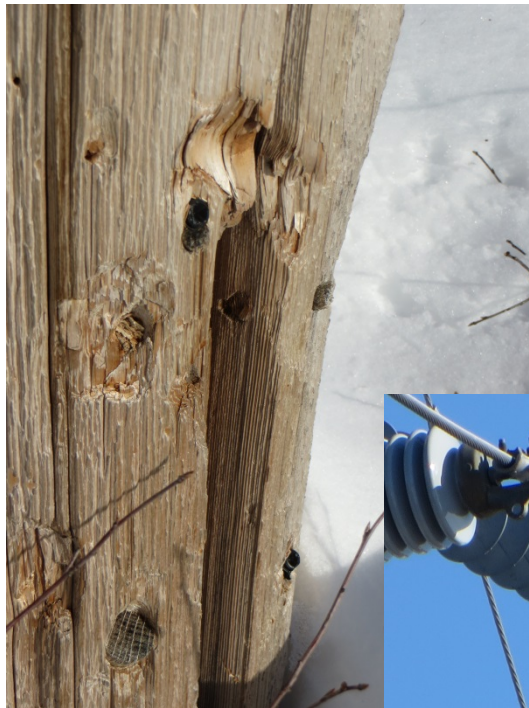
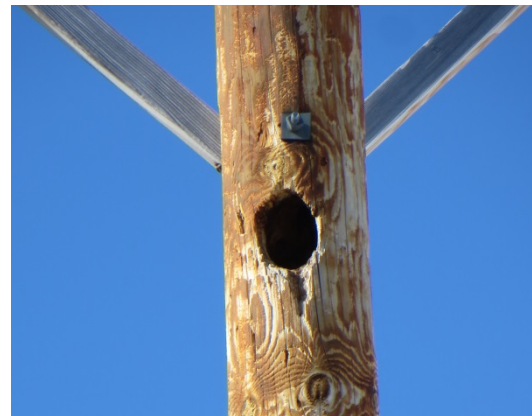
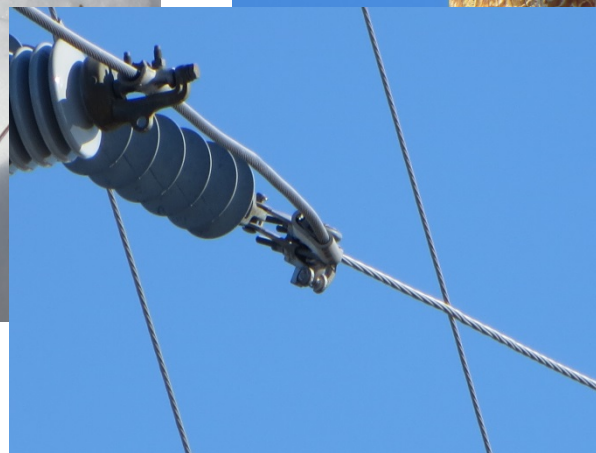
Line 6913 Rebuild (Presque Isle SS to Pole 160)

Rotting pole bases resulting in a leaning pole, other poles with cracked base and woodpecker damage, small 3/0 ACSR conductor

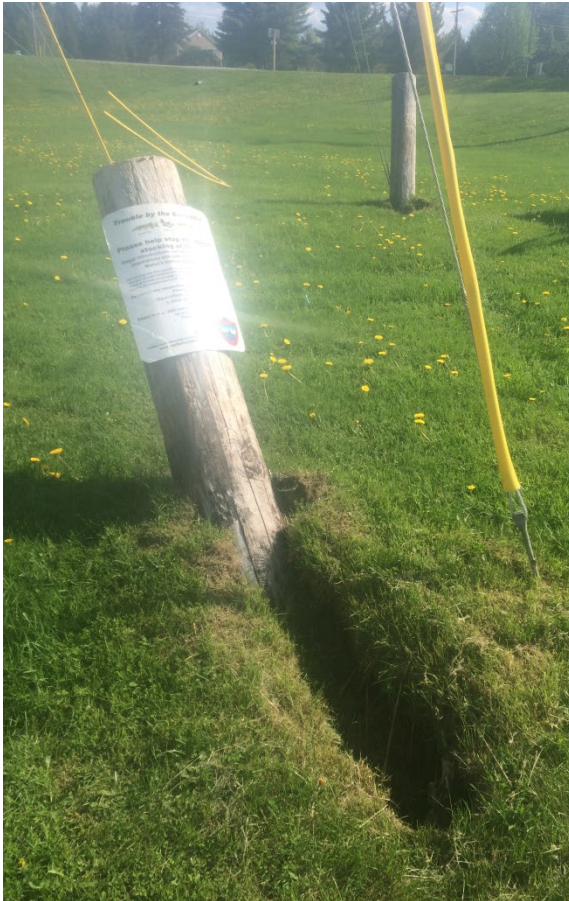
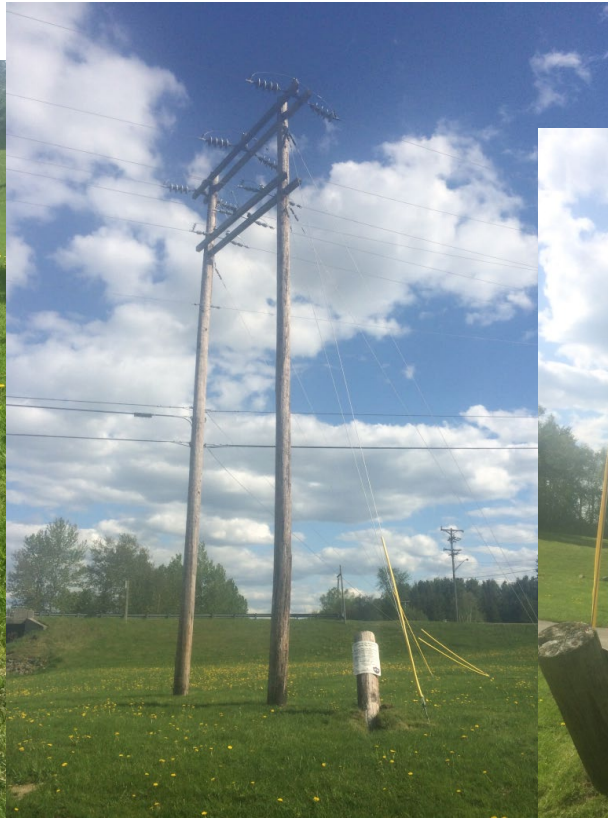
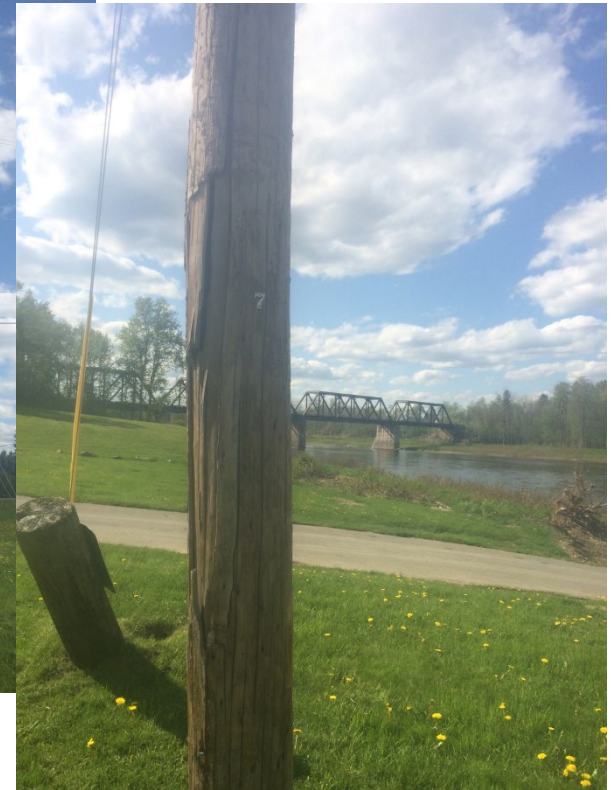
Line 6930 Aroostook River Crossing

**Aroostook River flooding
damaged poles and moved
protective barriers**

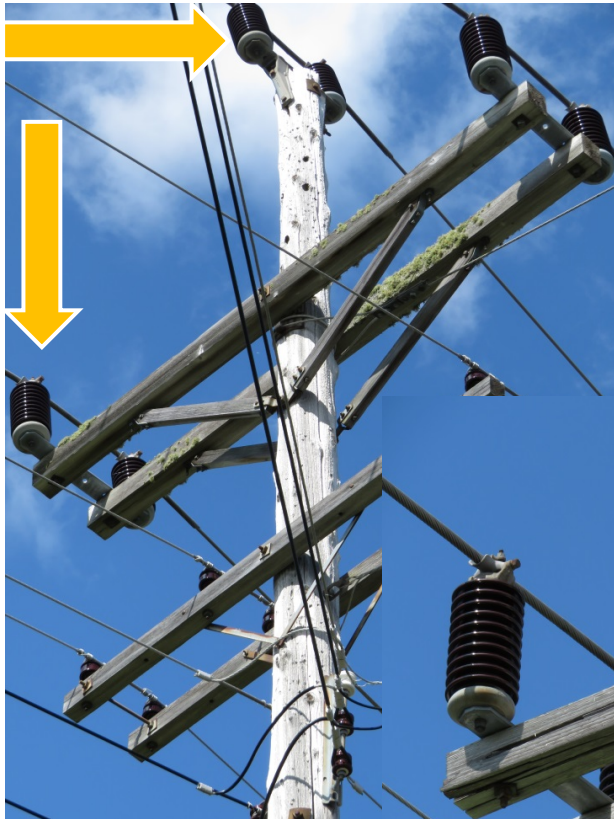
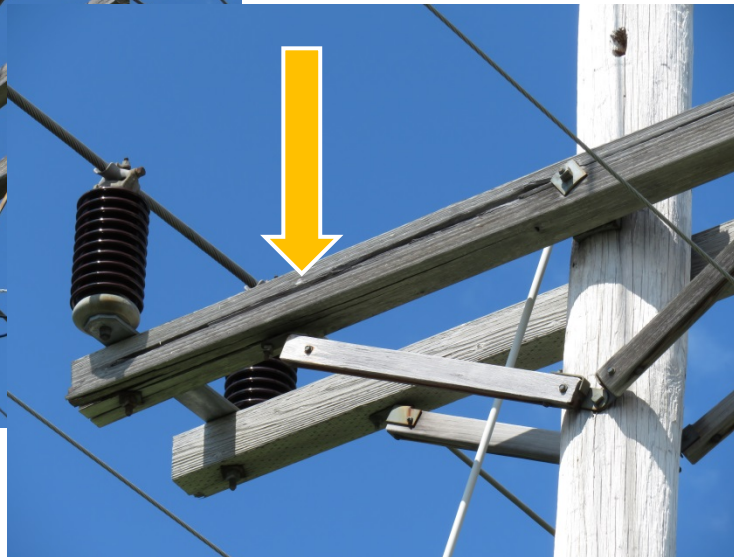
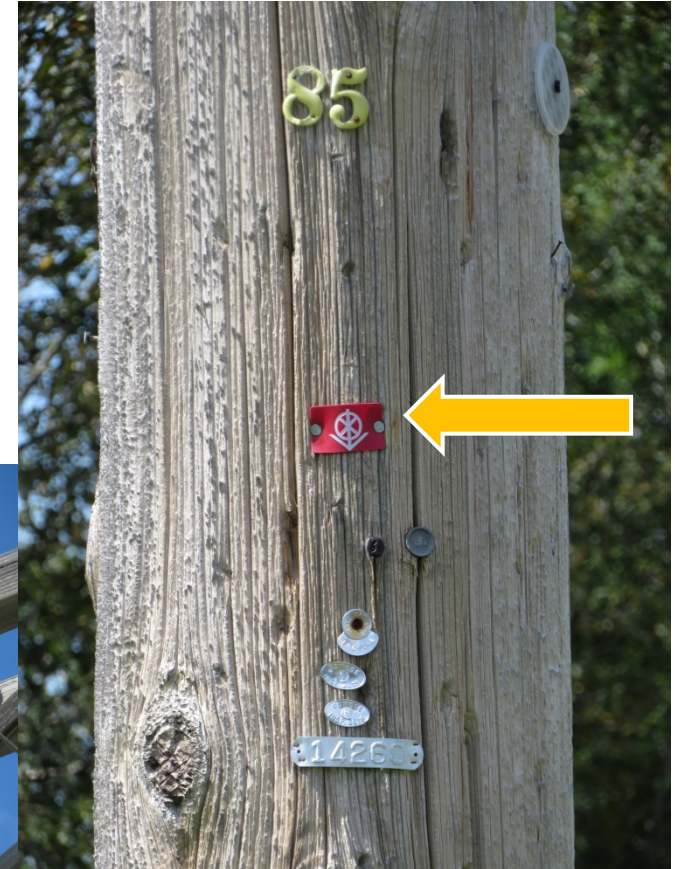
Line 6903 Rebuild (pole 57 to 127)

Brown glass post type insulators, cracked crossarms and rejected pole due to internal decay

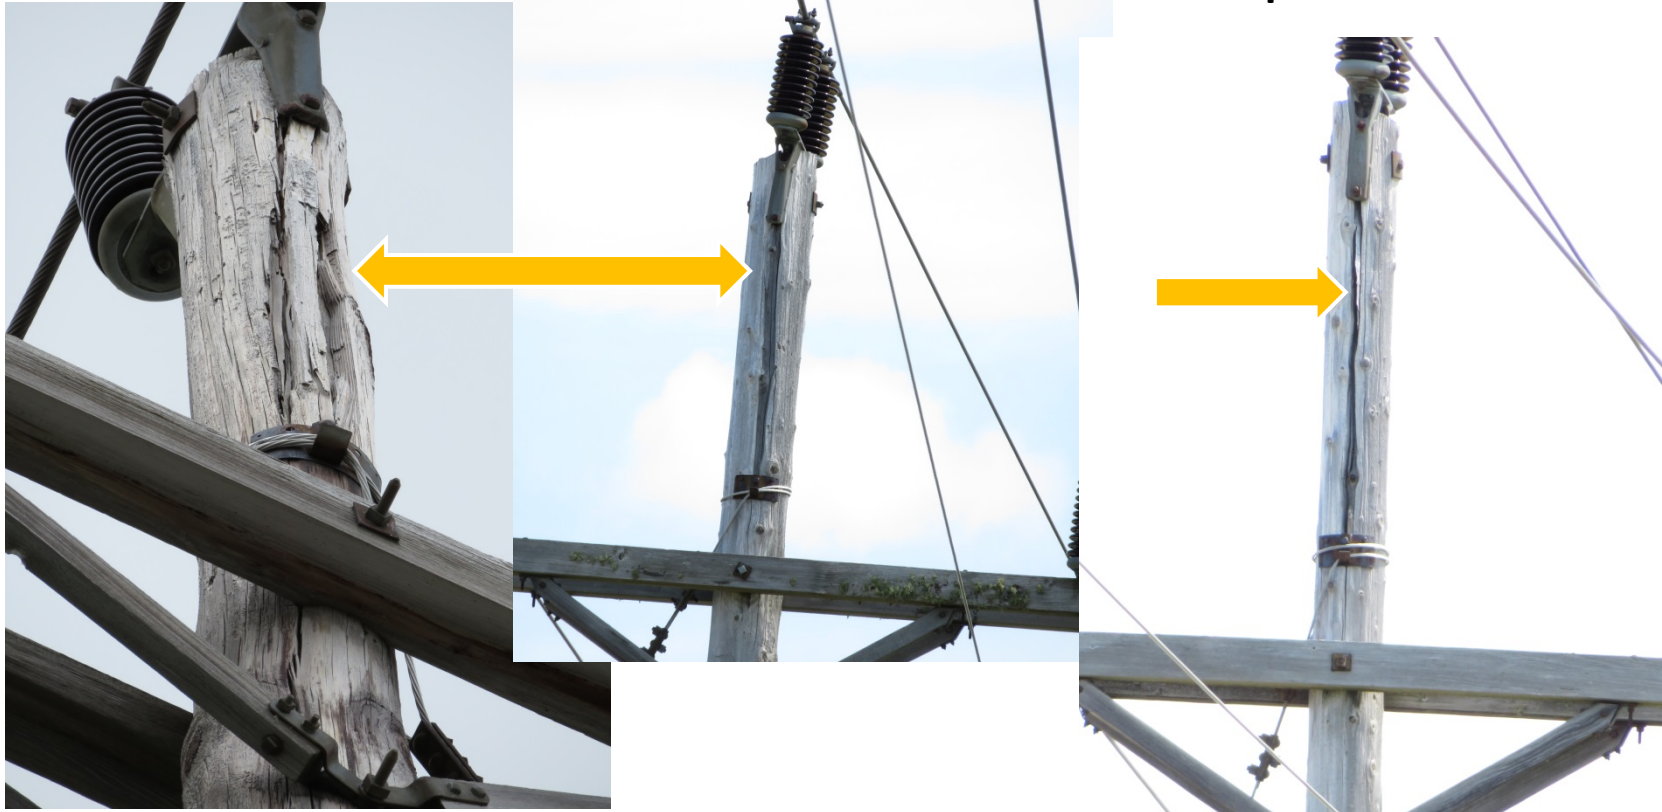
Line 6903 Rebuild continued...

Examples of past lighting strikes due to inadequate overhead shielding protection

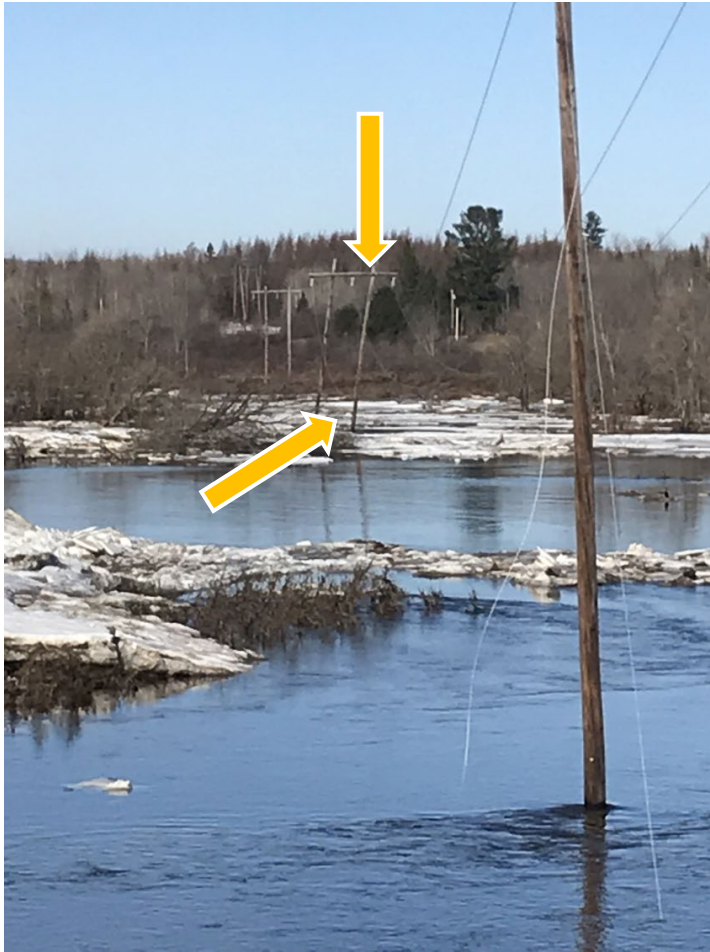
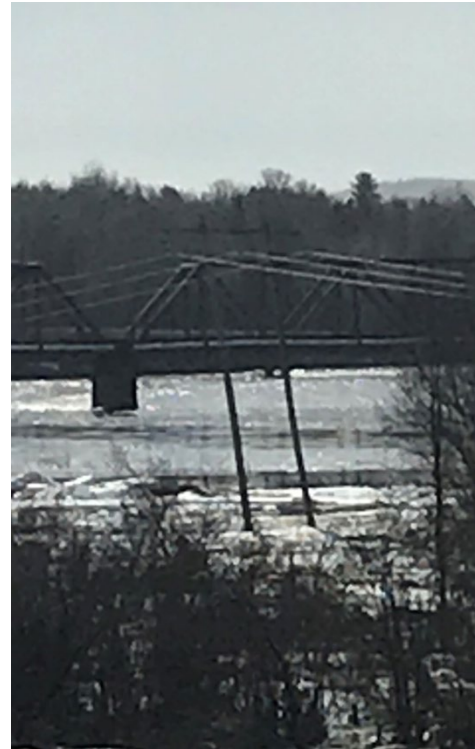
Line 6930 Salmon Brook Flood Damage

2019 spring flooding impacted structures alongside Salmon Brook destabilizing them and conductor too low for navigable waterway. Rebuild to include taller heavier class composite poles placed on berms with culverts and stone backfill.

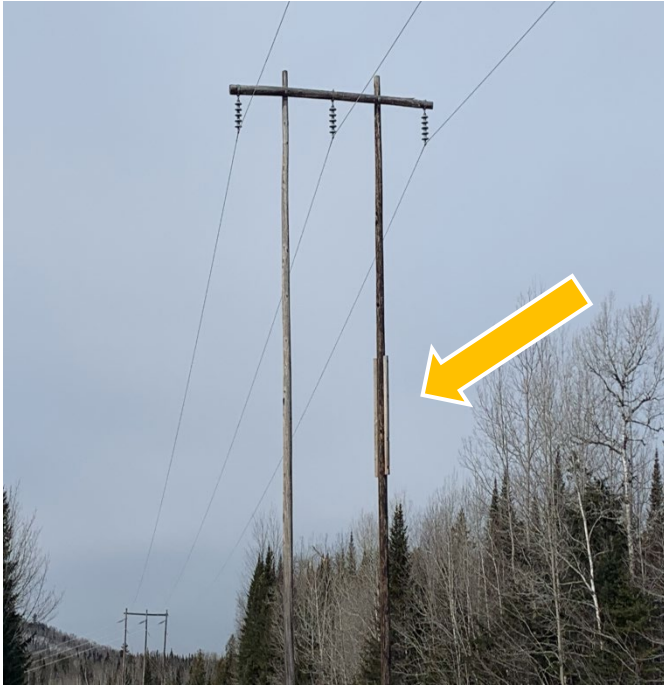
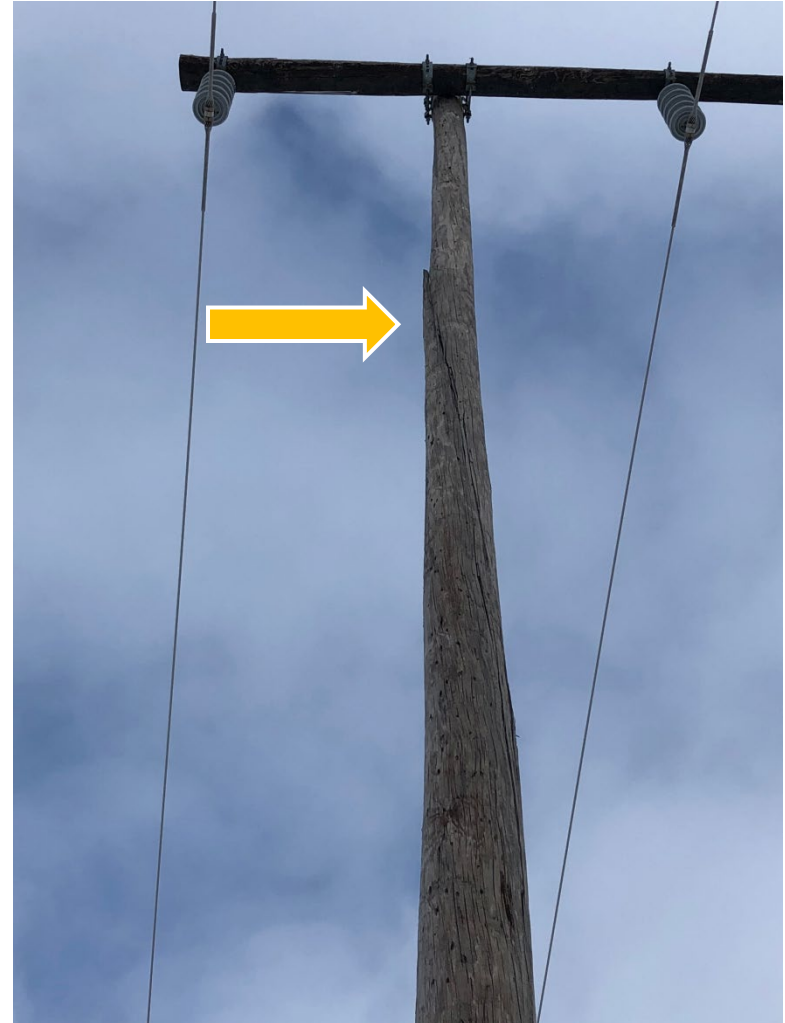
Line 6930 Targeted Maintenance

Woodpeckers nesting activity has damaged many poles while others need to be replaced because of wood pole failure

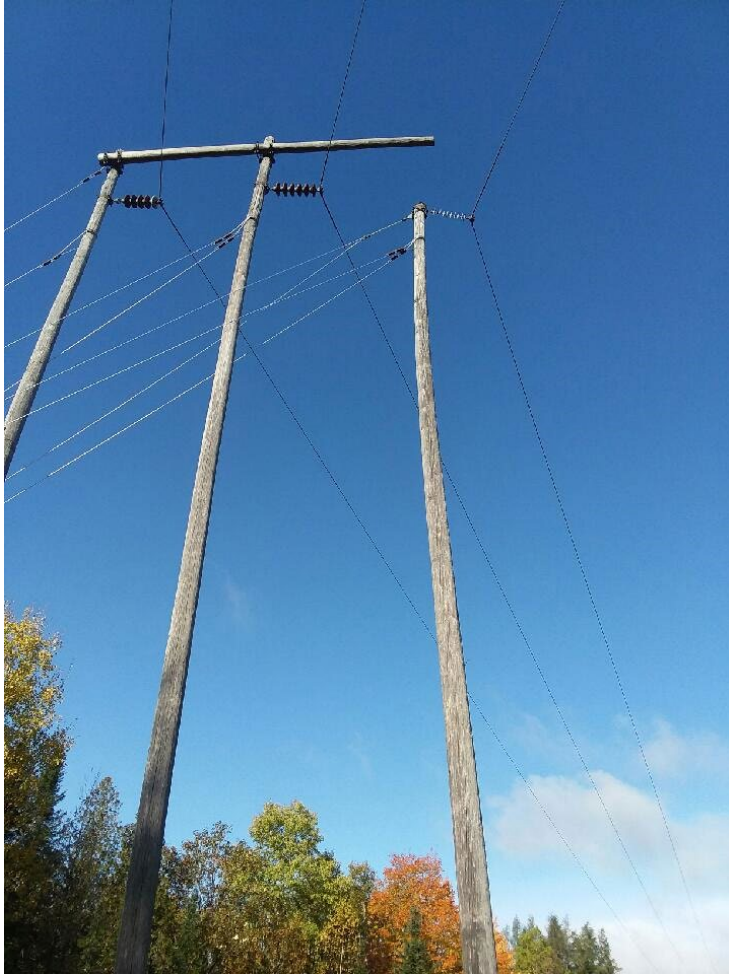
Line 6909 Condition continued...

Three pole light angle wood pole structure - top of right pole burned off by lightning strike, middle pole rejected due to insufficient shell strength caused by internal decay/rot

A UAS (drone) inspection is planned for 2020 to further assess above ground structure condition

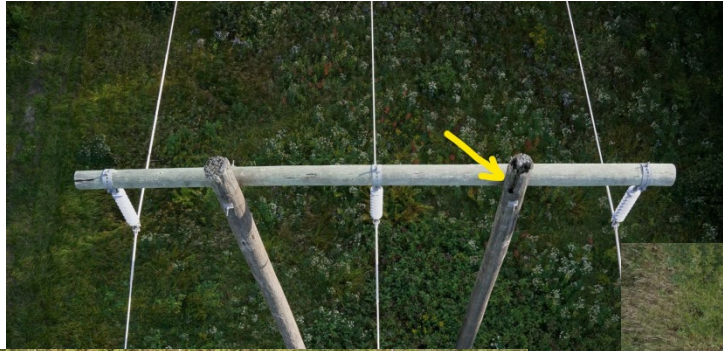
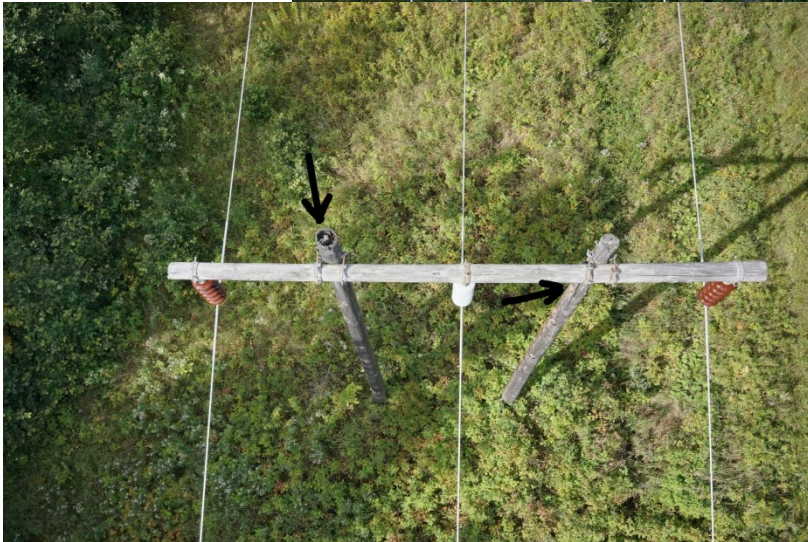
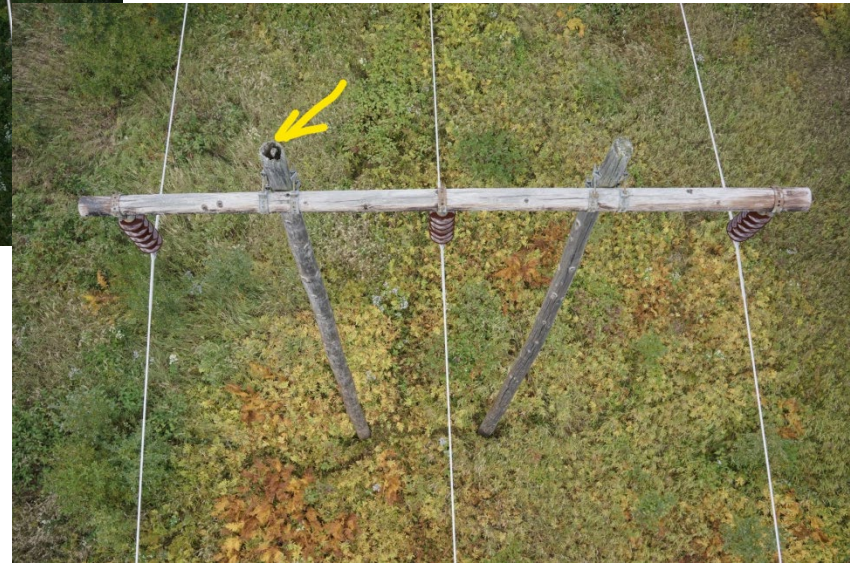
Line 6905 Drone Inspection Findings

Rotting crossarm and pole tops identified by drone inspection

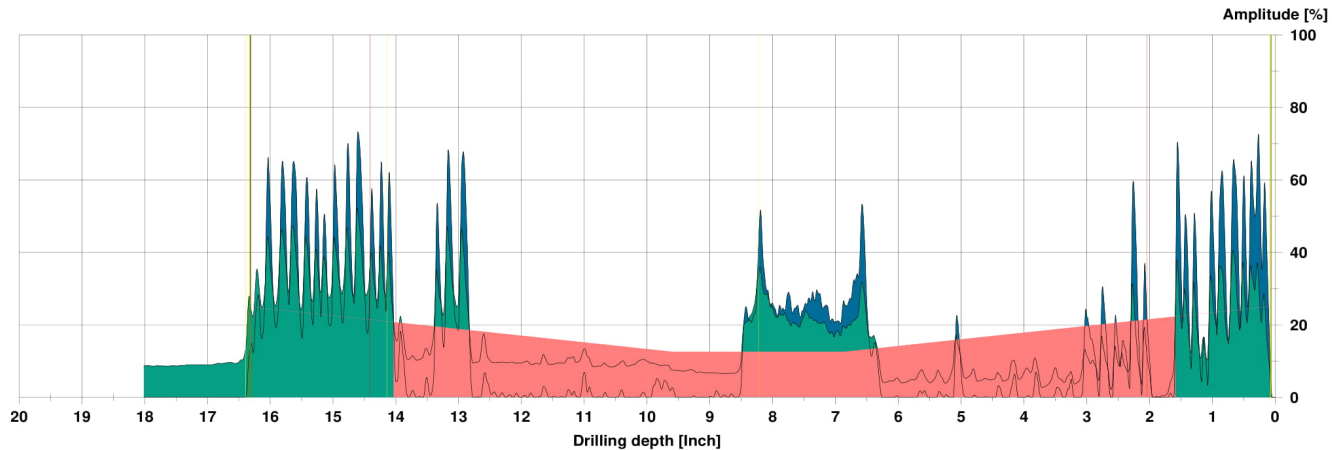
Rejected Wood Pole – Heart Rot

Program	: Pole - EMERA 1.00	Sum decay	: 40,7% 35,6% 76,3%
Pole type	:	Heart rot	: 40,7% 35,6% 76,3%
Measurement	: Auto diameter	Shell rot	: No No
Defect pattern	: Heart rot	Remaining wall:	9,3% 14,4% 11,8%
Result (auto)	: REJECT	Strength	: 56,1% 74,3% 65,2%

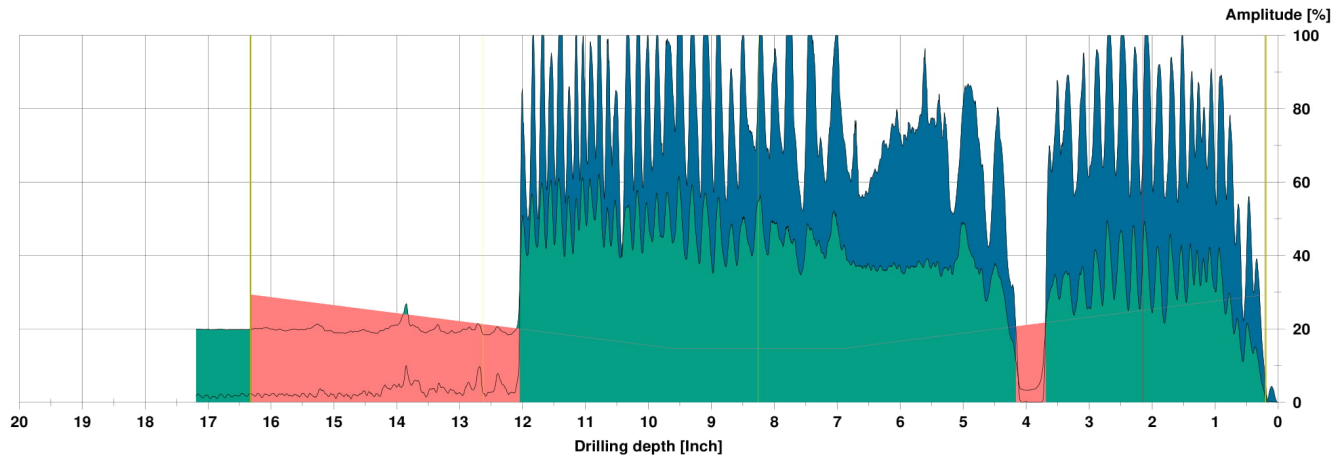
Rejected Wood Pole – Heart Rot & Shell Rot

Program	: Pole - EMERA 1.00	Sum decay	: 2,9% 0,0% 2,9%
Pole type	:	Heart rot	: 2,9% 0,0% 2,9%
Measurement	: Below soil level	Shell rot	: No Yes
Defect pattern	: Heart+shell rot	Remaining wall	: 21,7% ---
Result (auto)	: REJECT	Strength	: 89,7% ---
