2024 Chapter 330 Report

Northern Maine Transmission System Chapter 330 Work Plan Map

Line 6905 Condition

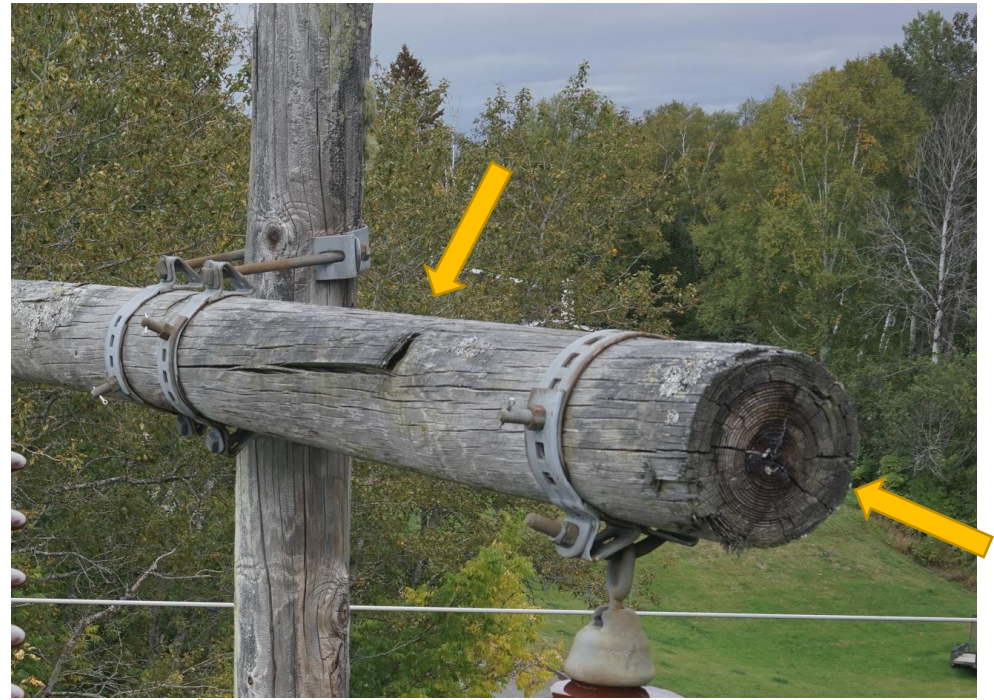
Line 6905 Condition continued...

Drooping crossarm under weigh of conductors likely caused by internal decay

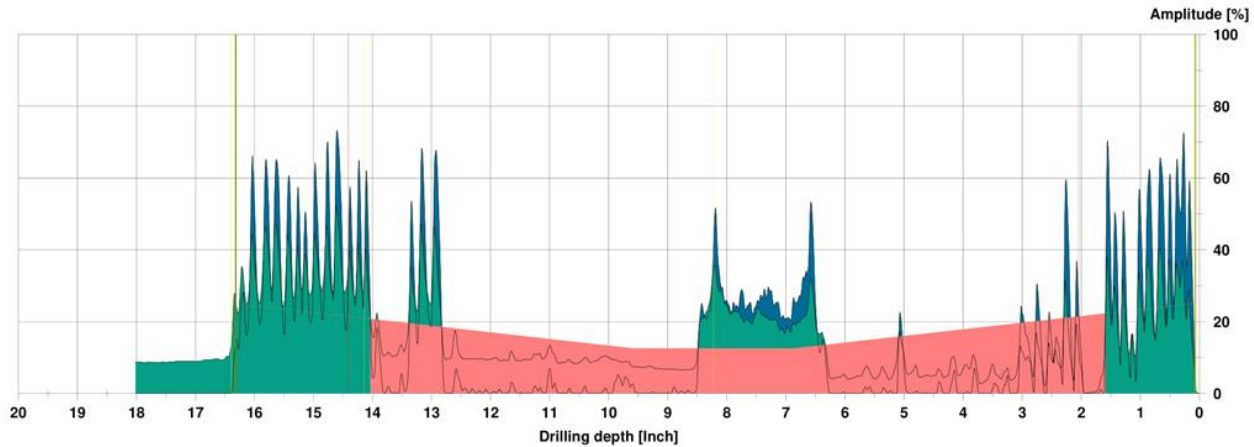
20781M013 (REJECT).rgp

Rejected Wood Pole – Heart Rot

Program :	Pole - EMERA 1.00	Sum decay :	40,7%	35,6%	76,3%
Pole type :		Heart rot :	40,7%	35,6%	76,3%
Measurement :	Auto diameter	Shell rot :	No	No	
Defect pattern:	Heart rot	Remaining wall:	9,3%	14,4%	11,8%
Result (auto) :	REJECT	Strength :	56,1%	74,3%	65,2%

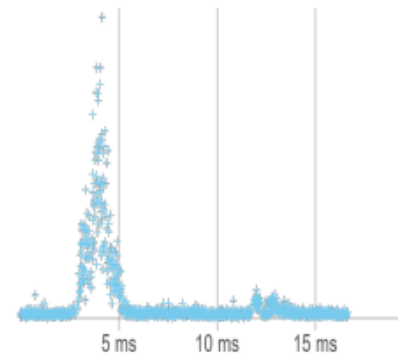
This is classified as corona, i.e., partial discharge into air. In most cases, corona is harmless.

Typically no action required unless power loss, audible noise, electromagnetic interference, or deterioration of nearby polymer insulators is a problem.

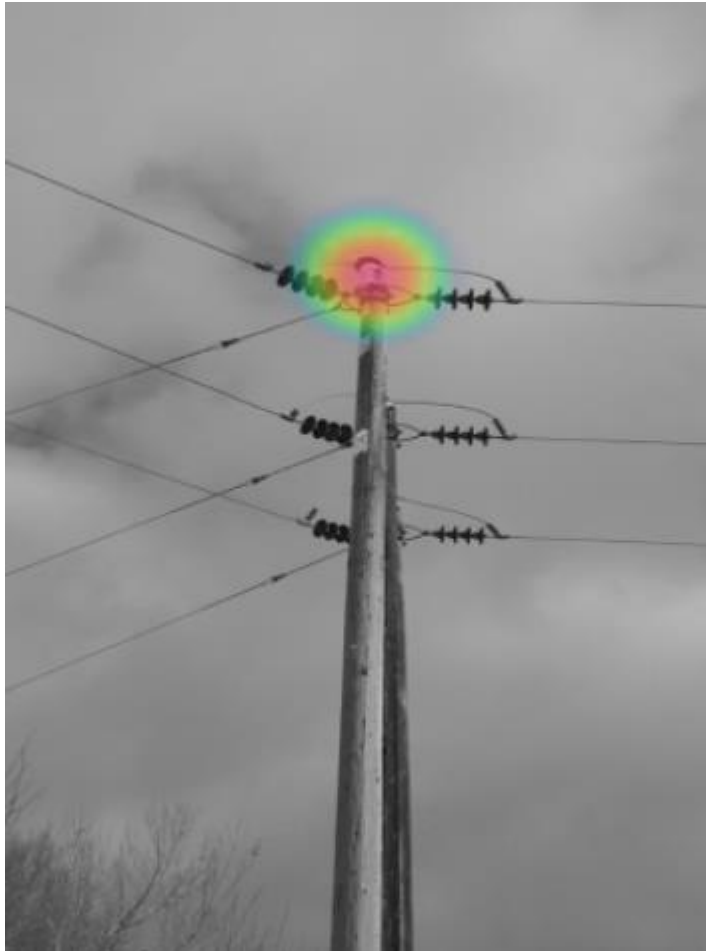
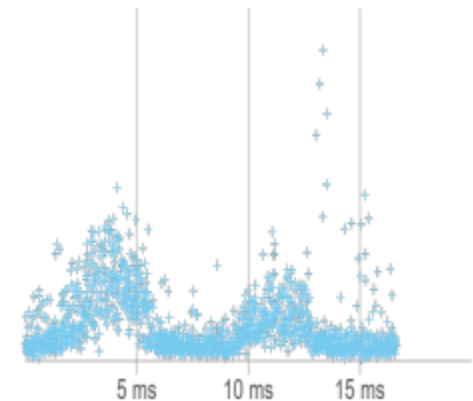
This is classified as a surface or internal discharge. The discharge appears to be strong and might rapidly escalate to complete insulation breakdown.

Immediate action. Visual inspection. Cleaning of polluted surfaces. Repair or replacement of the components.
