June 24, 2020

2020 PAG Meeting

Northern Maine Transmission System

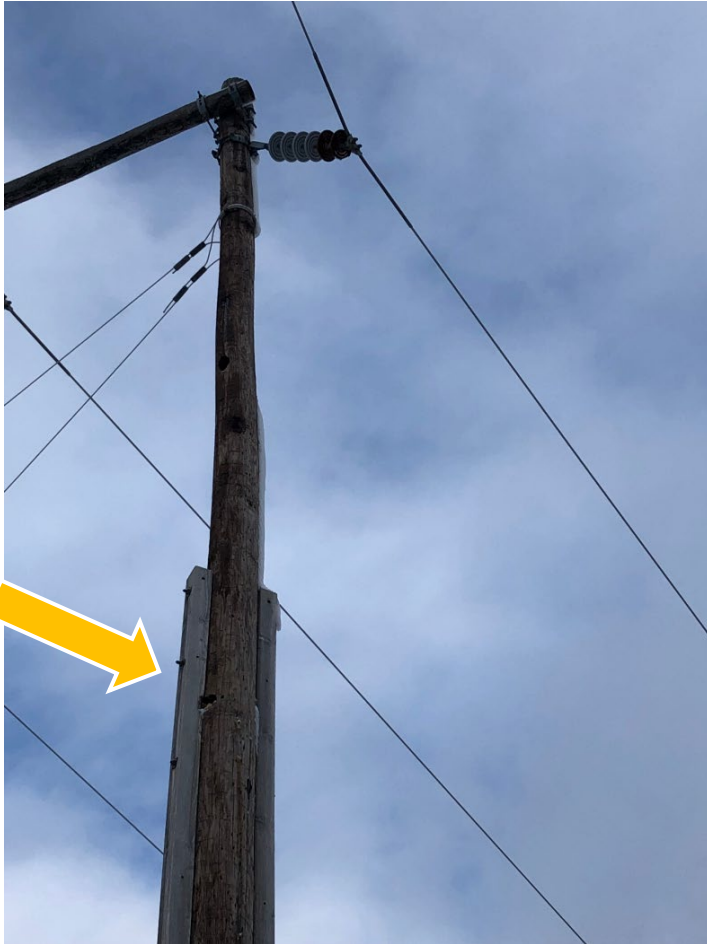
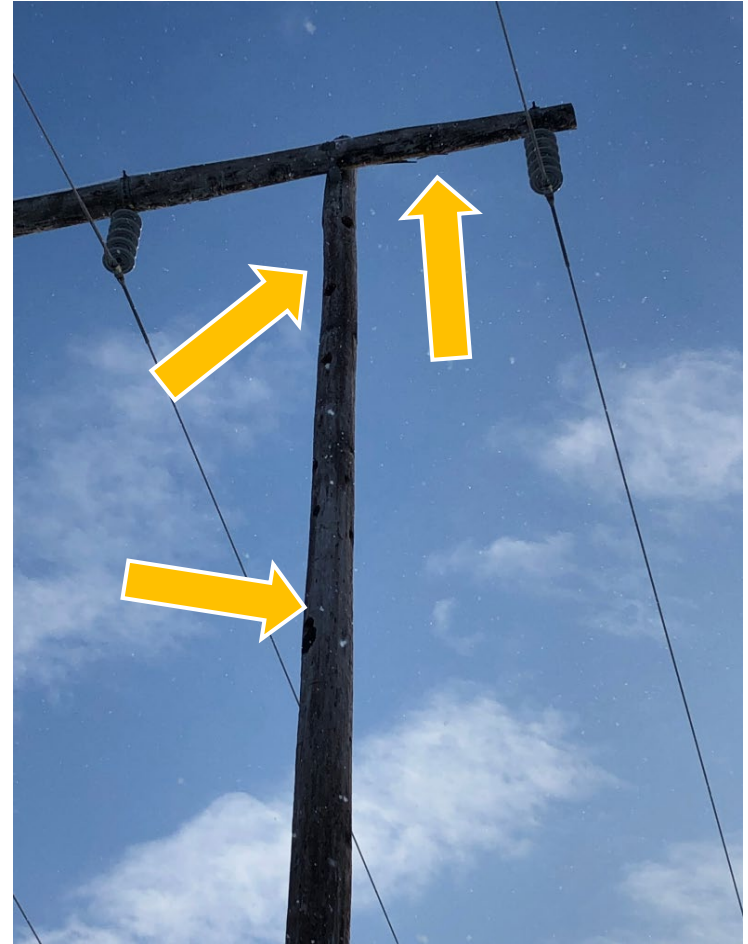
Line 6930 Targeted Maintenance

Woodpeckers nesting activity has damaged many poles while others need to be replaced because of wood pole failure

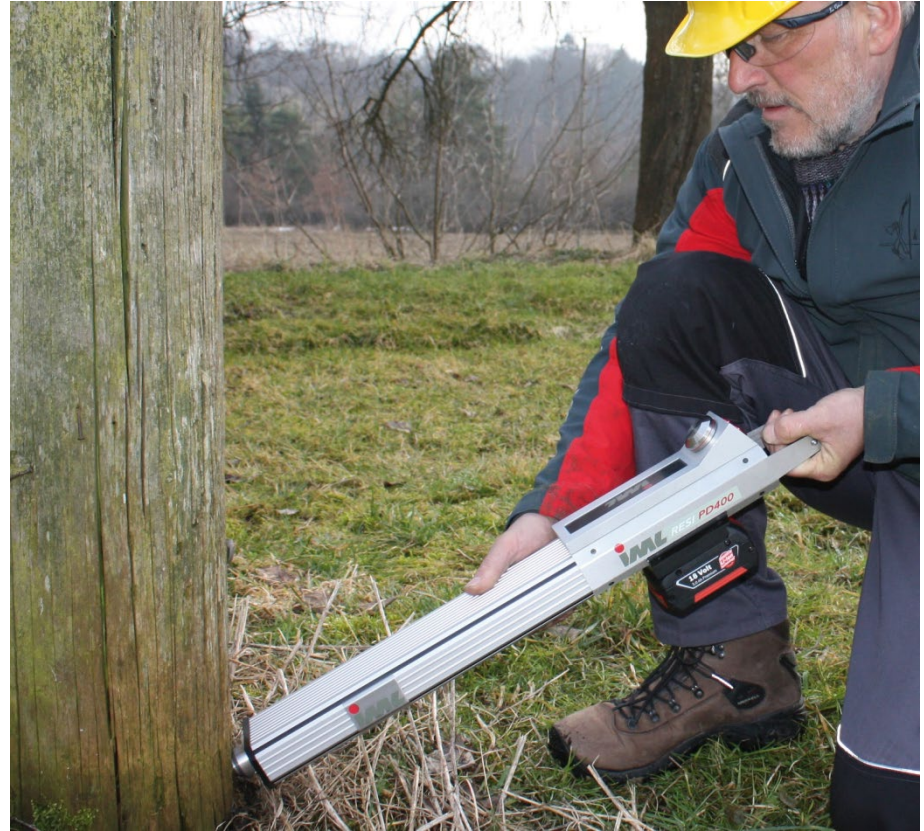
Resistograph Plot - Wood Pole in good condition

Program	: Pole - EMERA 1.00	Sum decay	: 0,0% 0,0% 0,0%
Pole type	:	Heart rot	: 0,0% 0,0% 0,0%
Measurement	: Below soil level	Shell rot	: No No
Defect pattern	: No decay	Remaining wall	: 50,0% 50,0% 50,0%
Result (auto)	: PASS	Strength	: 100,0% 100,0% 100,0%
